HYUNDAI
Technical Service Bulletin

GROUP RECALL	NUMBER 17-01-047
DATE JUNE 2017	MODEL(S) 2013-2014MY SONATA (YF) SANTA FE SPORT (AN)

SUBJECT: SONATA / SANTA FE SPORT GDI ENGINE INSPECTION
 / REPLACEMENT (RECALL CAMPAIGN 162)

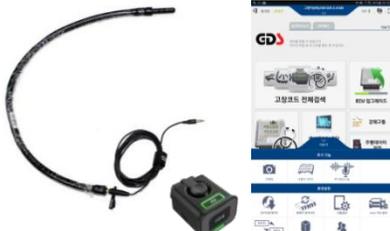
Description	Tool Part #	Image	Comment
Engine Noise Inspection Tool	G1XTD-CP001

For noise inspection
Torque Wrench Socket	09314-3Q100		Only needed if engine replacement required.
Injector Combustion Seal Ring Installer	09353-2B000		Refer to TSB 10-FL-019 for the detailed usage instructions

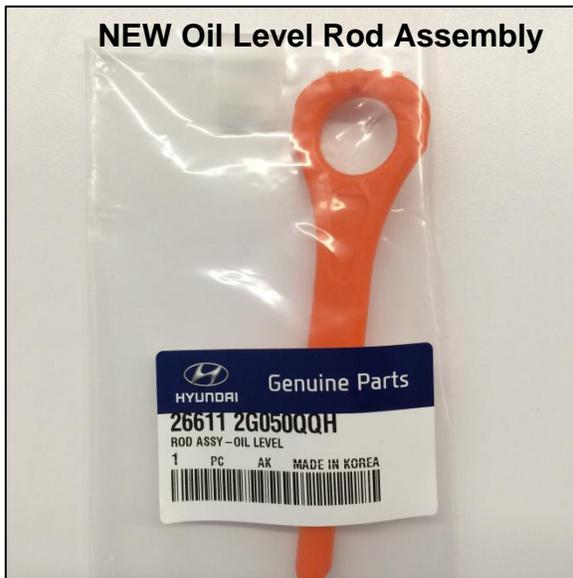
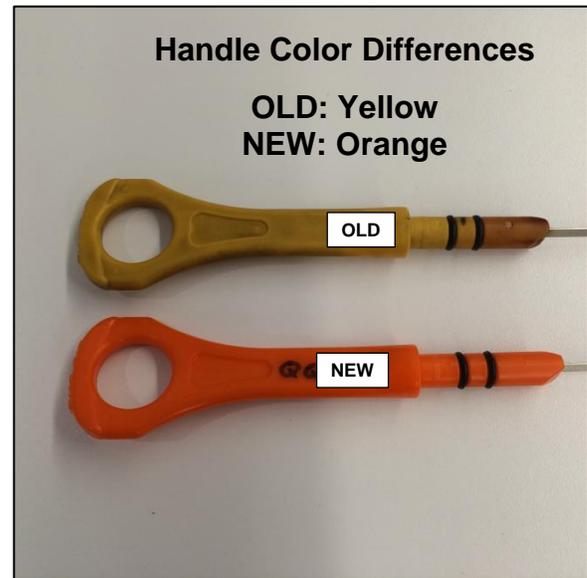
2. Replace the engine oil (4.8 quarts) and oil filter.
3. Replace the current Oil Level Rod Assembly with the new campaign part.
 - Remove and discard the existing Oil Level Rod Assembly (engine oil dipstick).
 - Install new ORANGE handle Oil Level Rod Assembly (P/N 26611-2G050QQH)

Note: Replace the dipstick only if the current dipstick's handle is yellow.

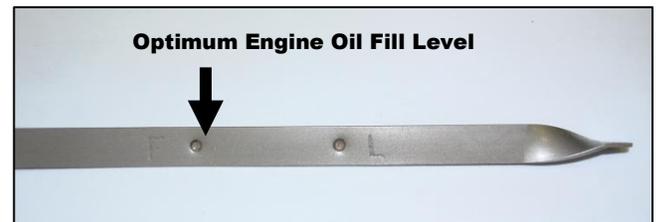
4. Start the engine and allow it to run for 10 seconds. Then adjust the engine oil level to near the "F" mark as shown in the picture.
 - Use Quaker State 5W-30 conventional type engine oil to complete this step.
 - Do not overfill.

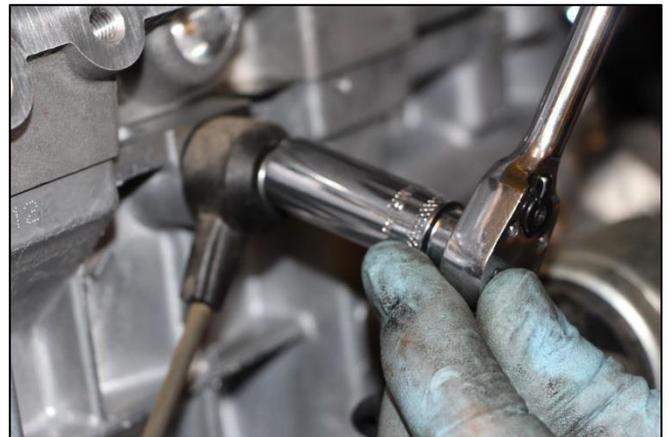
(Knock Sensor Fastener)

5. Remove and reinstall the engine Knock Sensor from the old engine to the new engine.

Tightening torque: 21Nm (15.5lb-ft)

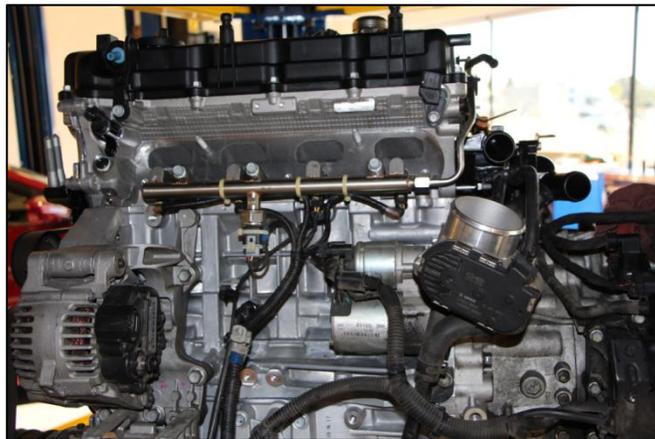
7. Reconnect and reinstall the engine front harness as shown.
- Be sure to properly route the opposite end of the harness end down towards the front of the engine.

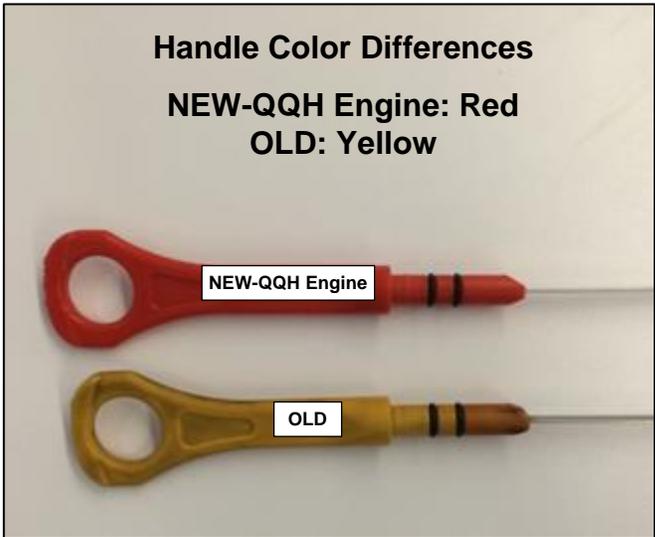
8. Install newly supplied Oil Level Guide and Oil Level Rod Assemblies to the new engine.
- Be sure to install the NEW Oil Level Guide (dipstick tube) to the NEW engine.
 - Install the NEW Oil Level Rod Assembly (dipstick) to the NEW engine.

The engine is shipped without oil and engine oil must be added at a later step.

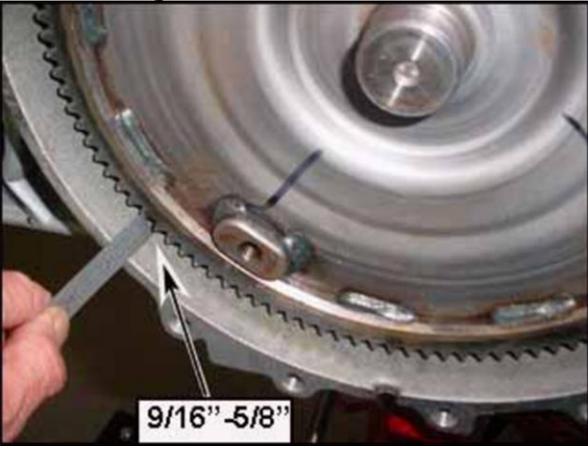
If the torque converter has moved from the fully inserted position, carefully push inward and rotate the torque converter until the converter is recessed approximately 9/16 - 5/8" (14 -16 mm) into the transaxle case when reinstalling the automatic transaxle.

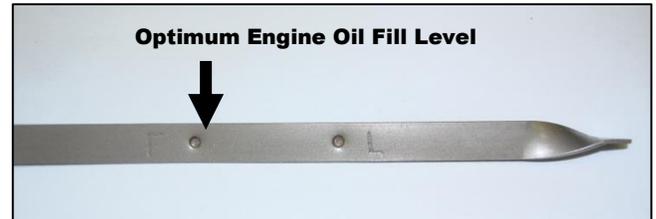
12. Start the engine to warm it up and begin the cooling system air bleeding process.
 - During this time, check for any leaks.
 - After the engine has warmed up to normal operating temperature, turn the engine off, wait a few minutes, and then adjust the engine oil level to near the “F” mark as shown in the picture.
